# 1000 cruise ships around.....

## Are their pilot transfer arrangements safe?

Some words on cruise ships and their compliance with SOLAS ch.V reg 23, IMO A.1045(27)?

By: Arie Palmers, registered Pilot

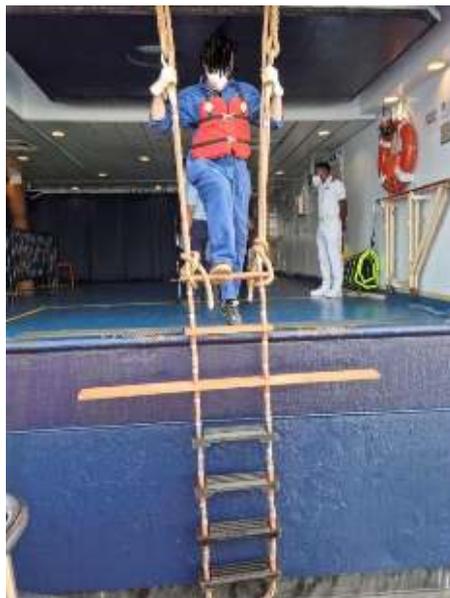
*A non-compliant arrangement, covid restrictions still in force obviously  
Facemasks do not only stop covid, but also rule out the necessity to blur a photo.....*

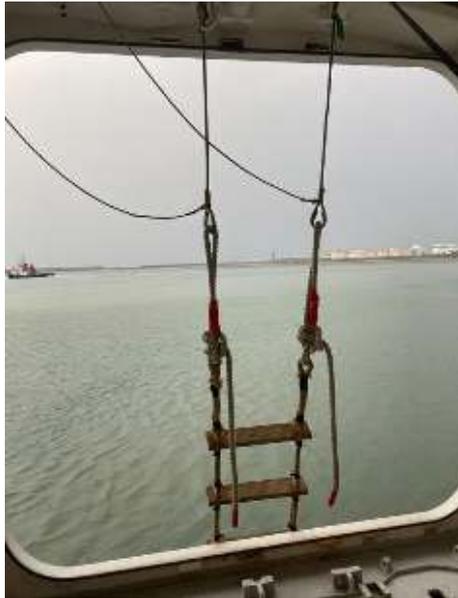
*Another non-compliant setup, dancing on the ceiling*

In the photo above we can clearly see the following non compliances:

- IAW SOLAS ch.V reg 23 rule 3.3.1.3 "each step shall firmly rest against the ship's side". Clearly not the case, the ladder is rigged from the deck-head and that way stability during usage is lost
- Does this ladder provide unobstructed access as per rule 4 of the requirements mentioned above? No, it is not: the pilot must crawl around the ladder or climb over the top of it to reach the entrance, therefore this is absolutely an unsafe practice!
- 4.1 also mentions that 2 handhold stanchions SHALL be provided, which clearly is not the case in this setup.
- Al lot of different types of vessels have this kind of arrangement, but then it is rigged adjacent to the pilot door and a small platform is provided.
- The simple solution in this setup is to secure it to deck and not the deck-head and install 2 stanchions at the required distance and dimensions as laid down in IMO A.1045(27) rule 5.

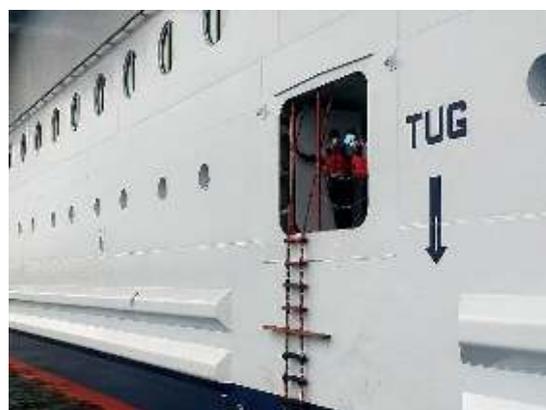
*a gift that keeps giving unfortunately...*

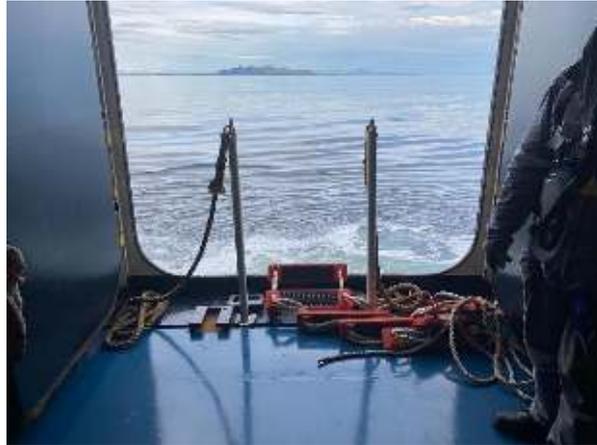
*A better setup yet still non-compliant*

At the setup above you can see that some (simple) changes have been made to get it right. The noncompliance you can spot is about the manropes being attached to the top of the stanchions:

SOLAS ch.V reg 23 rule 7.1.1 states that the manropes SHALL be secured to the deck.. That's fully understandable of course, yet the pilot ladder poster tells us something different:

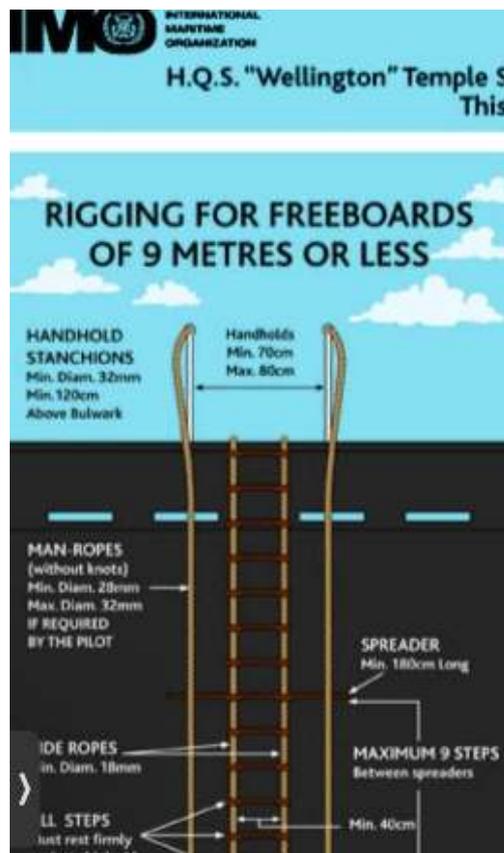
Basically, the crew seemed to have looked at the pilot ladder poster (left panel) and basically copied it into their own arrangement. The fact there are errors in the pilot ladder poster again proves to be very confusing. This is therefore the reason the poster is as we speak under revision and will be modified and updated.

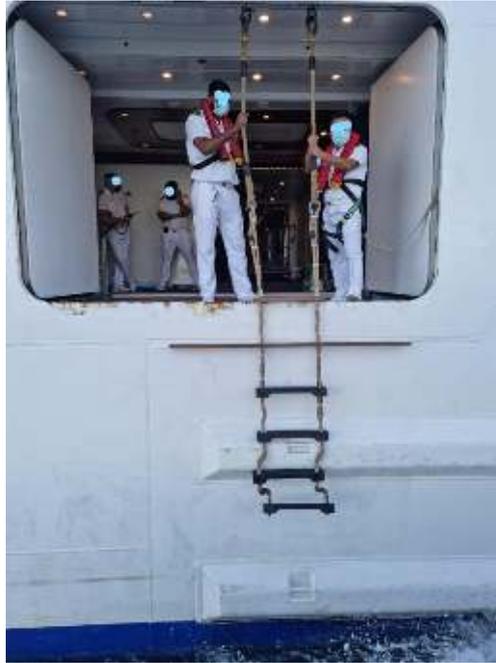
*Again, coming down from the deck-head*

The setup above... again the ladder comes down from the deck-head and we have already explained the consequences of it. When one of the cruise companies was contacted about their unsafe pilot transfer arrangement, the reply was that the vessel was built in 2004 and therefore did not have to comply due to a grandfather clause in SOLAS ch.V reg 23 and that IMO A.1045 was not valid because they were supposed to be under IMO A.889....

First, it is rather dreadful that a company that transports 1000s of people on a daily basis is hiding behind a grandfather clause (just for the record: there is no grandfather clause in the above-mentioned IMO recommendations.... IMO A.889 had been revoked when IMO A.1045 came into force.)

In this particular case I would just refer to rule 2.1 and 2.2 from SOLAS ch.V reg 23: "All arrangements used for pilot transfer shall efficiently fulfil their purpose of enabling pilots to embark and disembark SAFELY." Is this setup safe? No, it is not.. Don't use it...

Besides all the above, you can also see the ladder isn't against the hull: ship's fendering prevents that. Also, this can prevent the safe approach of the pilot launch and therefore should be cut back for at least 6m. (IMO A.1045 rule 6 and SOLAS ch. V reg 23 rule 3.3.1.3)

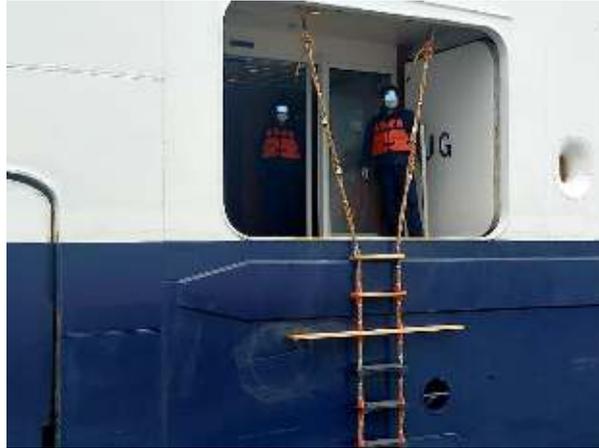
*A bit better...or..less bad..*

In the photo above, which is a similar vessel as a bit more up in the article, we can clearly see some adjustments have been made: stanchions are in place (are they 70-80cm apart from each other??), but can someone climbing the ladder use them? In my opinion it is good practice that these vessels are thinking about adjustments and executing them. Should they have gotten into the rules and contact the right people, it would have been correct already; now still further adjustments must be made. Again the ladder is not against the hull due to belting/fendering.

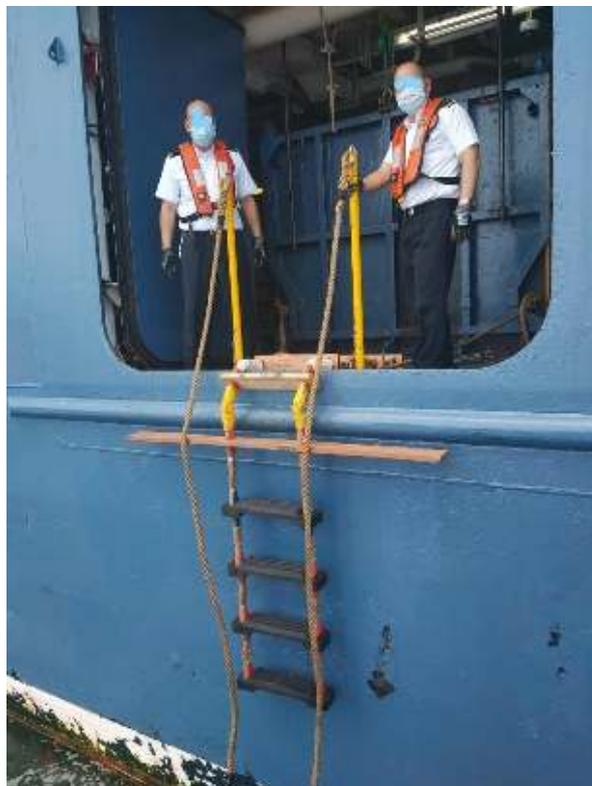
*Again, non-compliant..*

On this photo at least the ladder is secured to strongpoints on deck, and the correct stanchions are in place. Seems quite ok to use except for 3 other non-compliances: we see (again) the manropes secured at the top of the stanchions. We already saw the cause of this practice and besides that, they have covered the side ropes for protection.. It is not allowed because IMO A.1045 states that the side ropes must be of uncovered rope. When the side ropes are covered, it is not possible anymore to see whether they are damaged or not. Another point is that covered side ropes don't dry but stay wet.. This will cause rot and rapid deterioration of the side ropes. We see here the ladder is suspended over a sharp deck-edge, which probably is the reason they have covered them. An easy solution to this problem is the so called 'fish plate' ( a piece of half round pipe to guide the ladder down). And finally the ladder is (yet again) not against the hull due to fendering/belting.

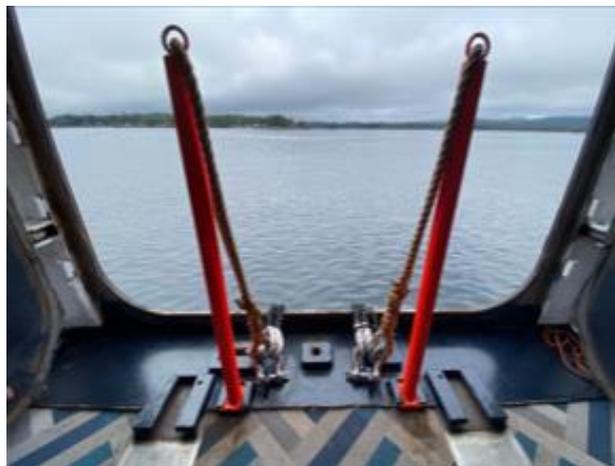
*It can be done!!!!*

- Secured to strongpoints on deck
- Manropes secured to strongpoints on deck
- Correct stanchions

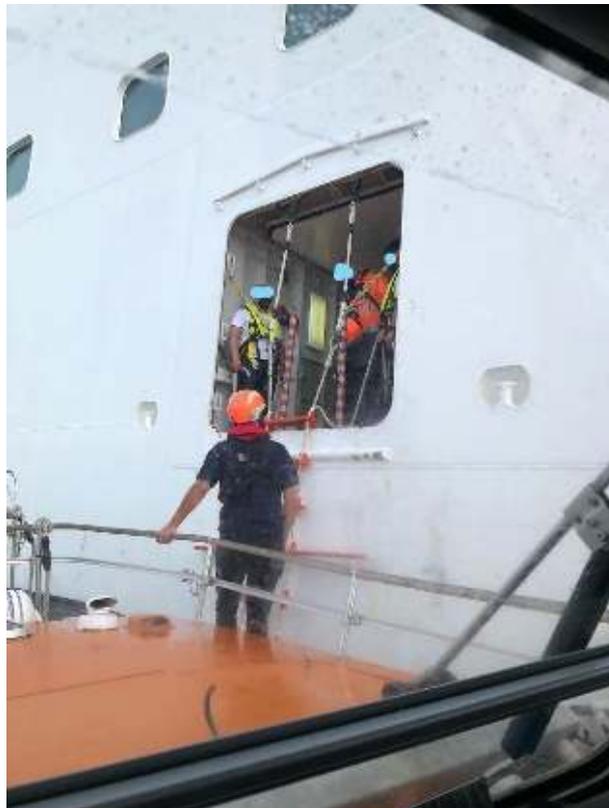
*Dancing on the ceiling again.....*
