# Mariners' Alerting and Reporting Scheme

MARS Report No 358 August 2022

## Two anchors are not always enough

As edited from NTSB (USA) MAB-21/15

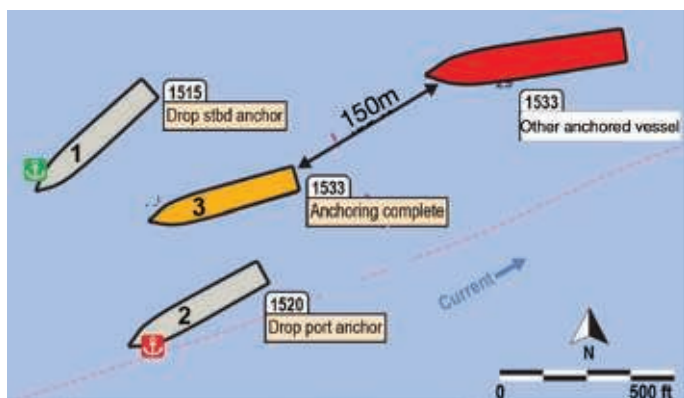
The starboard anchor was let go (position 1 in the diagram). The vessel then manoeuvred to port and, five minutes later, the port anchor was also let go (position 2). The starboard anchor was heaved to four shackles on deck and the port to three shackles in the water. About 15 minutes after the port anchor was let go the pilot informed the Master that the anchoring was finished. The pilot was satisfied with the situation (position 3), but recommended keeping the engine on short standby due to the inclement weather that was due to arrive and the strong river current. Another issue was that the vessel's stern was only 150 metres from the bow of another ship anchored astern (shown in red in the diagram).

The pilot left the vessel a few minutes later. Unknown to him, the vessel was not in a stable condition and continued to yaw between the anchors.

- The first minutes after anchoring are important. Special attention should be given to ensuring the vessel's anchors are indeed holding and the vessel is stable.

- Given the distance of just 150 metres from the stern of the vessel to the bow of the other anchored vessel, the anchor watch alarm radius setting of 180 metres was too large to provide a timely alarm of the ship dragging.

- When at anchor, all means to detect vessel movement should be employed. In particular, the radar should be used to crosscheck ranges to shore or other anchored vessels.

- In this case, there were four shackles on deck on the starboard anchor and three in the water on the port anchor. Best practice with opposing forces ahead (such as in a river current) would be to have equal amounts deployed on each chain to avoid unequal distribution of stress. Unequal distribution of stress could result in one anchor taking the load, then dragging and putting the load on the other anchor, which in turn takes the load, and then drags. This in effect nullifies the advantages of deploying two anchors. Readers may remember another recent MARS report where dragging anchor in a crowded anchorage caused problems; M202216.

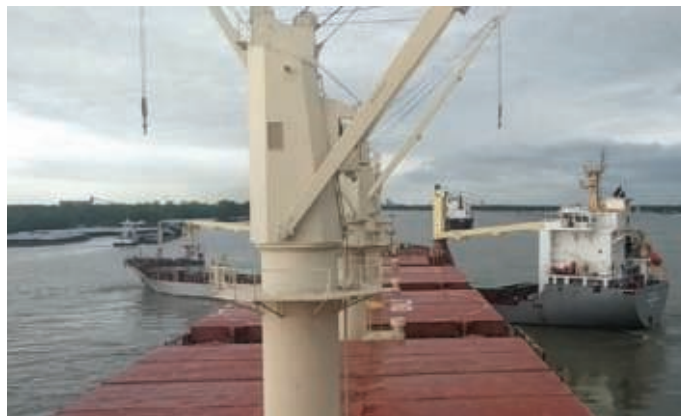
At 1639, the OOW became aware that they were now too close to the other anchored vessel. He contacted the engine room and engine control was received on the bridge nine minutes later. The Master began using full ahead engine, along with the bow thruster and rudder, to reduce the swing and bring the ship ahead. By this point, the ship was unable to turn to starboard away from the other anchored ship. At 1655, with the first vessel now broadside to the current and pushing on the bow of the other anchored vessel, both vessels were now dragging anchor.

Tugs were requested to help hold and stabilise the vessel. The first tug arrived on scene about 30 minutes later. A further 30 minutes passed before pilots arrived on both vessels, but more tugs were needed to extricate the vessels from their position. Although these arrived some time later, the vessel nonetheless hit a shore dock at a speed of 6 knots before its bow grounded on the river bank. Damage to the two vessels and the dock were estimated at \$16.9 million.

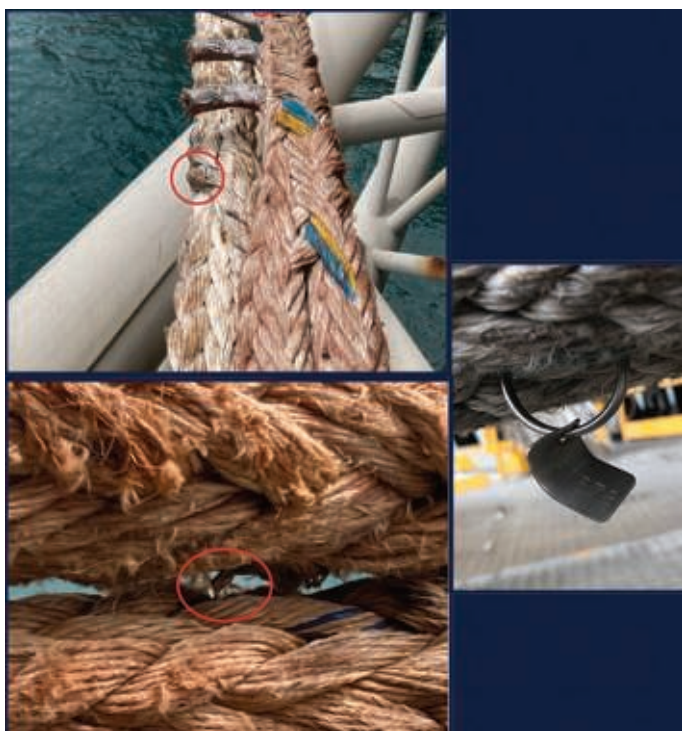
→ During berthing operations at a loading terminal, the line-handling crew were surprised to find metal rings and tags entwined within the yarns and strands of a vessel’s lines. These objects present a potential catch point and/or finger entrapment hazard for anyone handling the lines. There is also a risk that these objects could detach and become projectiles when lines are under load or when lines are being run. This was the fourth vessel in six months to have lines with such hazards. The terminal authorities grew concerned and made a MARS report.

It is likely that the rings and tags are items associated with materials used to pack the lines themselves. It is also possible that these objects could have become embedded within the lines during usage.

- When bringing a new line into service, ensure all packing and extraneous materials are removed from the line before use.
- It is good practice to observe and inspect berthing lines at every use; as they go out and when they come on board. The inspection should cover the general state of the line, but be aware of any objects that may embed themselves into the fibre of the rope during usage.

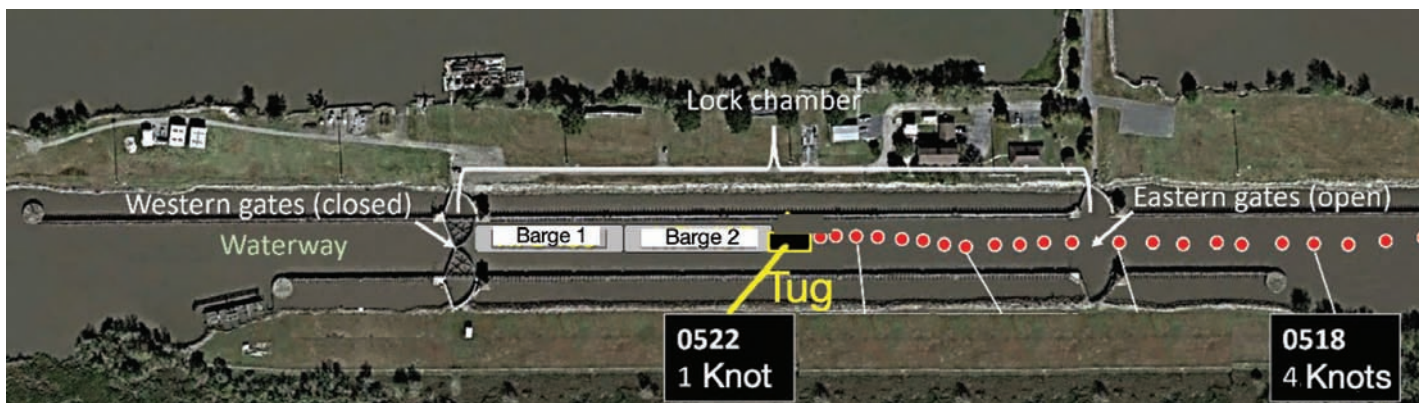
With the tug and barges now at a speed of about two knots, the Master received a distance report from the deckhand and, realising they were close to the front of the lock, put the engines to full astern. The tow continued to slow but was still making about one knot when the starboard bow of the forward barge (1 in picture) struck the closed western lock gate.

The official investigation found that the Master’s performance and decision making were probably negatively affected by sleep inertia. Sleep inertia can be a factor for 30 minutes or more after waking, especially in demanding situations that require high levels of attention and cognitive demand. Further, waking during a circadian low, such as in this case at 5am, and partial sleep deprivation, can amplify the effects of sleep inertia.

- The company operations manual required that a change of watch was not to occur during ‘a critical move’. Examples included operations involving ‘bridges, locks, and docking operations’. The requirement is one of common sense and, in this case, does seem fully justified.

- Fatigue has many negative effects on performance and is notoriously hard to objectively assess by its victims. Sleep inertia is a silent companion to fatigue and mariners would be well served to be aware of its existence.

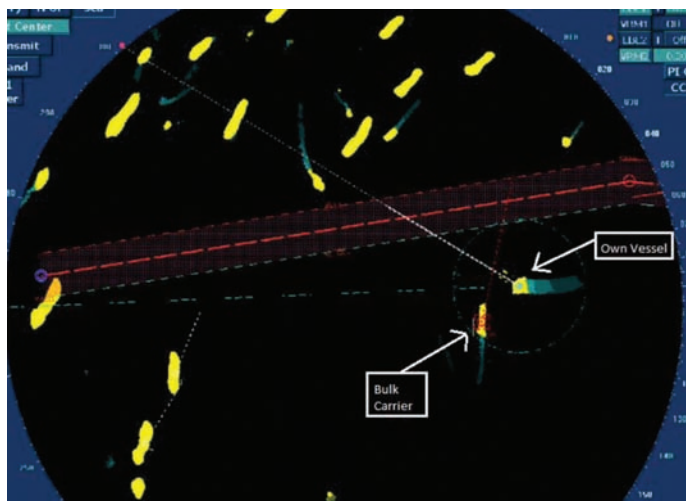
➔ In darkness, a vessel was proceeding to a busy anchorage under the con of a pilot who had just boarded. The pilot and the Master engaged in small talk as they proceeded and there was also an OOW and a lookout on the bridge. Another vessel underway in the vicinity had recently altered course to port and, unknown to the bridge team or pilot, was now in a potential close quarters situation. Almost 10 minutes passed before the potential close quarters situation was observed by local VTS and the bridge team alerted to the danger by VHF radio.

Only now, with the other vessel just 0.3 nm away, was it plotted. There was initially some confusion as to the speed of the other vessel as the value was changing; but this was to be expected in the first minute after plotting as the ARPA target acquisition algorithm needs to refine the calculations. Emergency course alterations were made and the bridge team tried to communicate with the other vessel by VHF radio. As the distance decreased between the two vessels, the bridge team, now under some stress, sounded a long blast on the fog horn. Finally, the other vessel passed astern only 35 metres away.

- A common mistake when a pilot boards is for the bridge team to relax; the unstated assumption is that the pilot has everything under control. Not so! The bridge team must continue to do their jobs in full support of the pilot and visa versa.
- As part of a bridge team, never assume that someone else will see it. It is possible for any member of the bridge team to make an error or miss a cue. YOU may be the only one that identifies a potentially hazardous situation, and for this reason, every bridge team member should be alert.
- The danger signal is at least five short blasts.
