Securing of Pilot ladders at intermediate lengths

Professor Nicola Symonds

Director and Principal Consultant of nC² Engineering Consultancy University of Southampton, UK

IMPA Rotterdam, 26th Congress. 23rd April 2024

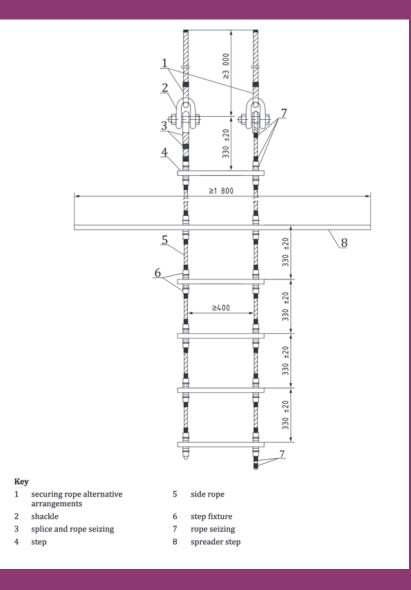
Pilot ladder from BS ISO 799-1 2019

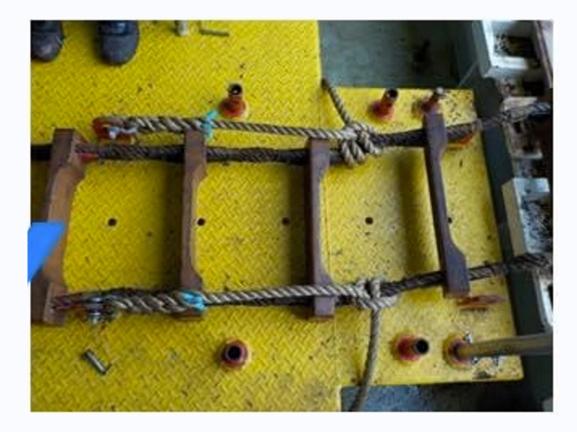
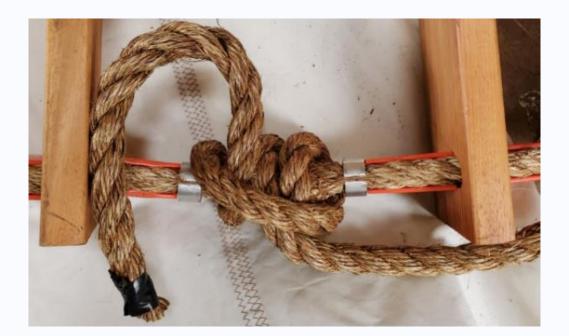
- Cow or rolling hitch using rope or straps
- Wear in the system is a concern

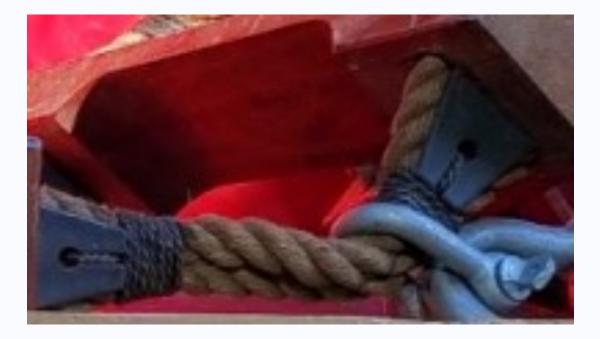
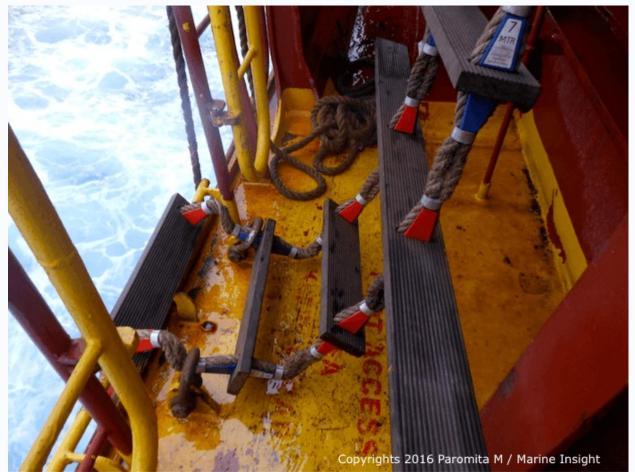
Passing the side rope through a shackle

- Metal 'D' shackles
- Damage to step fixings is a concern

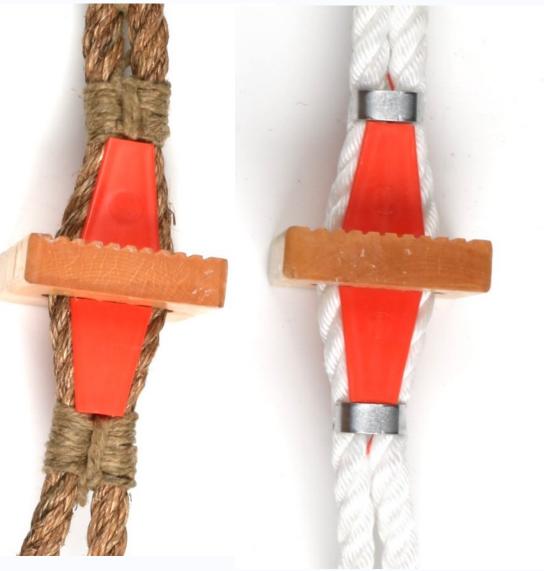
Ladder construction for tests

- 20 mm natural manila (4 strand)
- 20 mm polypropylene with an inner colour contrast core weaving
- Rope seizings (match rope type)
- Aluminium alloy clips (on both rope types)

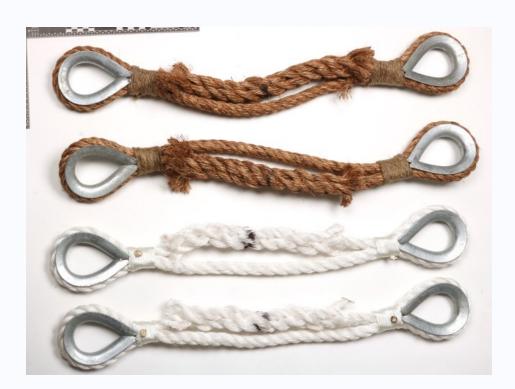
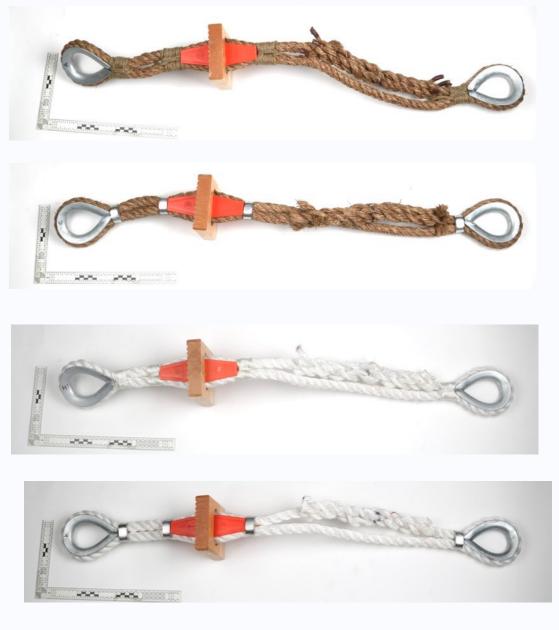
Testing: Baseline

- 100 N pre-tension, 10 kN loading
- Extension (under load & residual)
- 10 repeat loadings (bedding in)

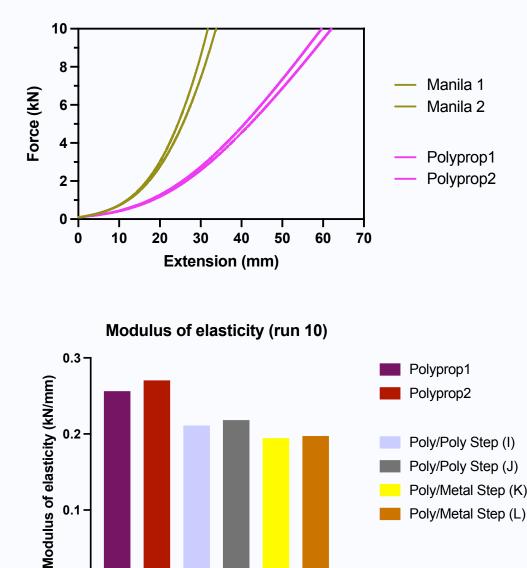
Baseline Results CONSULTANCY

- Consistent test results lacksquare
- All ropes required bedding in lacksquare
- Under 10 kN tension: lacksquare
 - Polypropylene extended by 8-9%,
 - Manila extended by 4-5%, _
 - Adding steps made them slightly more 'stretchy' (less stiff)
 - No measurable influence from rope seizing or metal clip

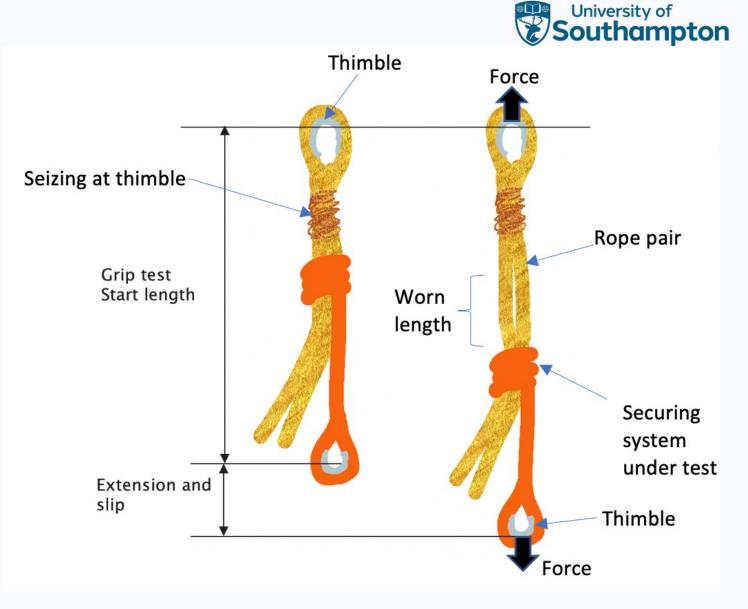
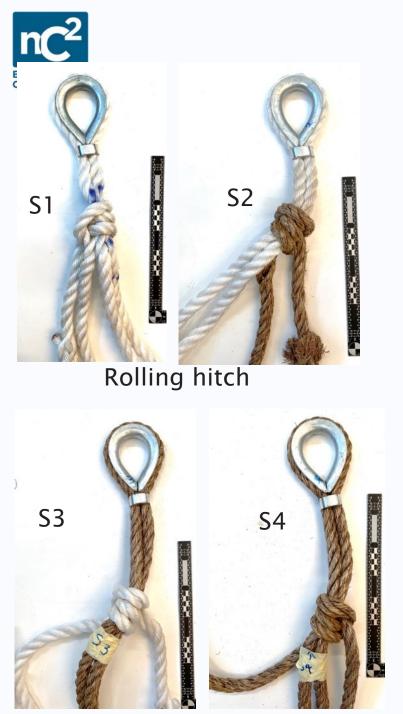
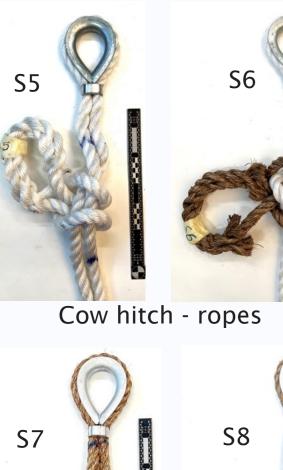
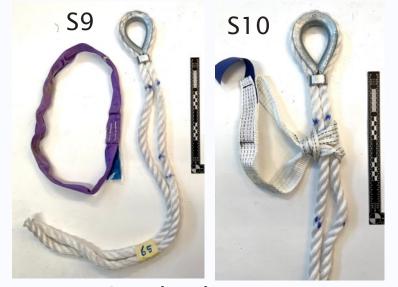
Testing: Hitches

- Hitch types
 - Cow hitch
 - Rolling hitch tugged
- Securing systems
 - Ropes
 - Manila rope
 - Polypropylene rope
 - Cargo straps: 1000 kg 1m circular endless web slings
 - Purple sleeve
 - White stitched
- 50 repeat tests each

Cow hitch - straps

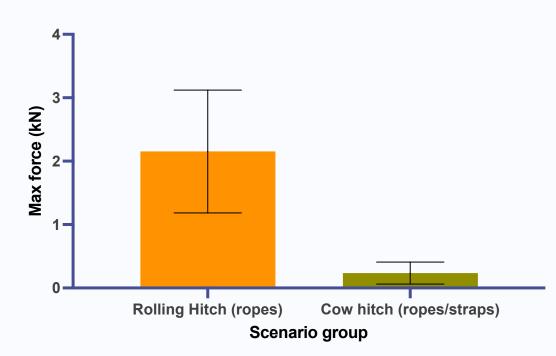
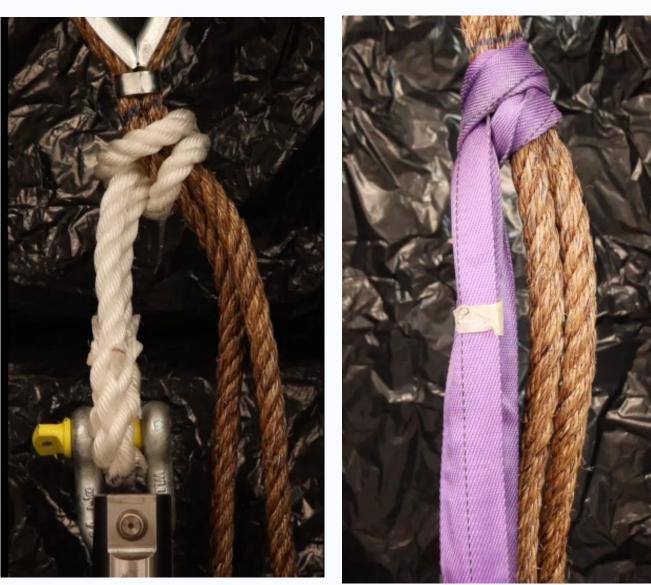
Results of hitch testing: Cow hitch

- Cow hitch did not grip and carry as much load as rolling hitch
- Cow hitch slid when loaded
- No ladder pair wear noted after 50 runs

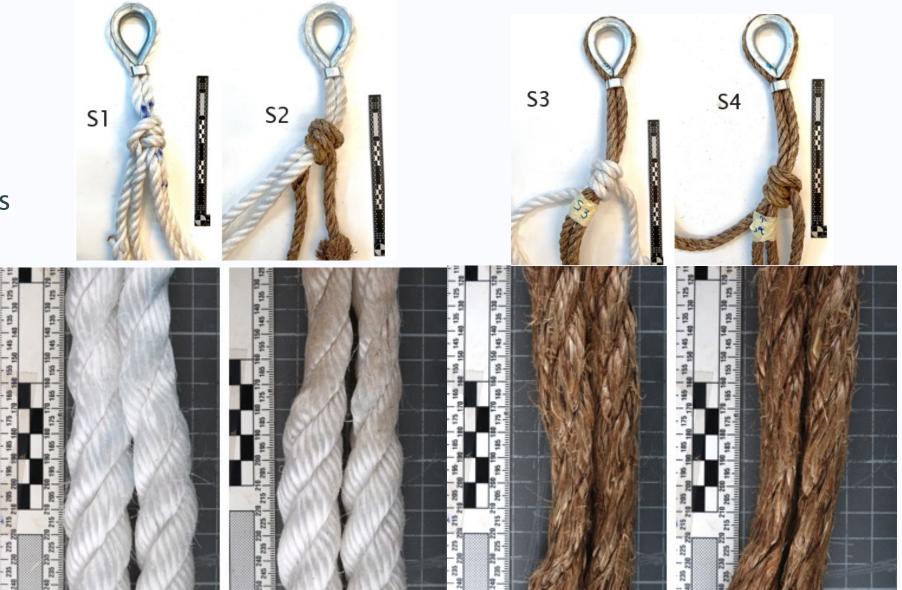
Results of hitch testing: Rolling hitch

Deformation and discolouration of side ladder rope pair after x50 cycles in one location

Rolling Hitch	Manilla, Polypropylene securing rope	2.2kN (average)	Signs of squashing and discolouration on side ropes, but no material damage was observed	Complex knot, high skill level. Requires a pre- load before use to ensure superior grip force	The rolling hitch method resulted in signs of squashing and discolouration on side ropes, but no material damage was observed. The rolling hitch demonstrated holding performance which was at least 77% better than a cow hitch. However, the superior performance of the rolling hitch is conditional on the knot being tied correctly and being pre-loaded before use. If	Recommended for use but holding performance is conditional

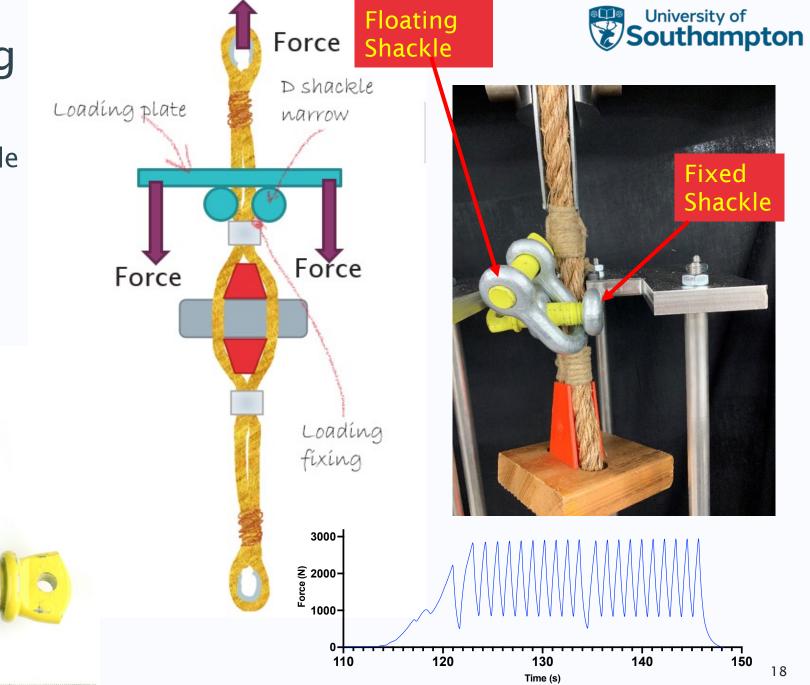
'D' Shackle testing

36 mm

- Ladder system pulled through/against a 'D' shackle
- Two shackle sizes

27 mm

Loading sequence applied 1500 times

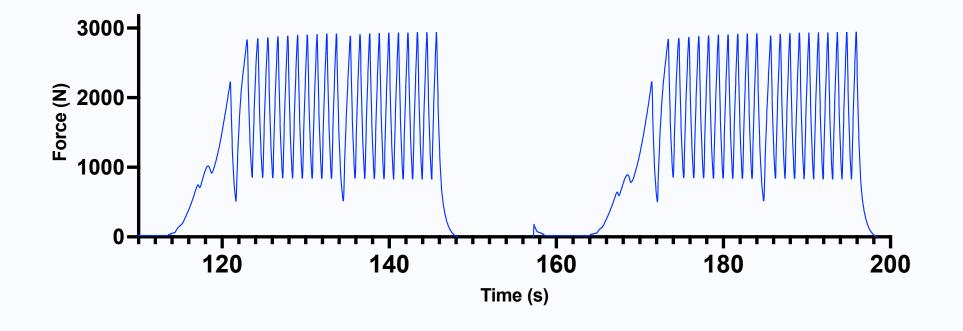
• Representing forces on one side of the ladder (single rope pair) for a climb up and then down

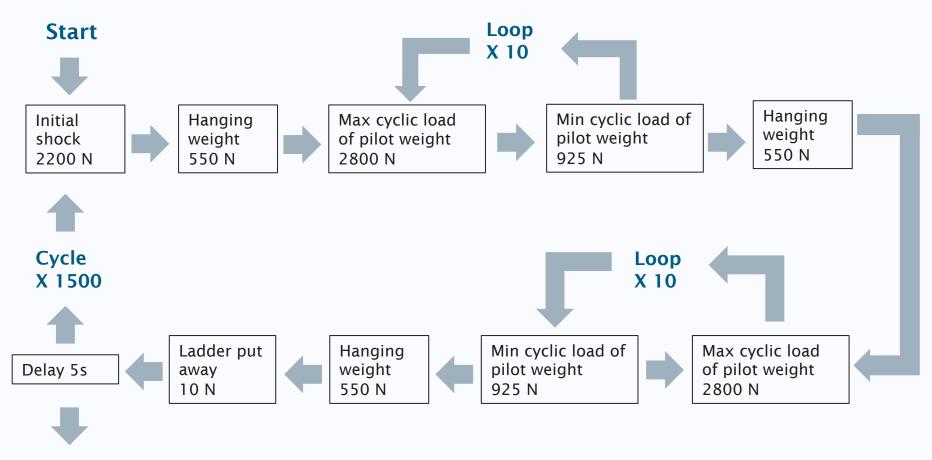
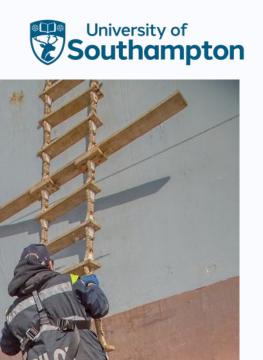
• Representing forces on one side of the ladder (single rope pair) for a climb up and then down

Description	Result	
Weight of Ladder	110 kg (1100 N)	
Weight of Pilot	125 kg (1250 N)	
Weight of kit	25 kg (250 N)	
Length of ladder	9 metres

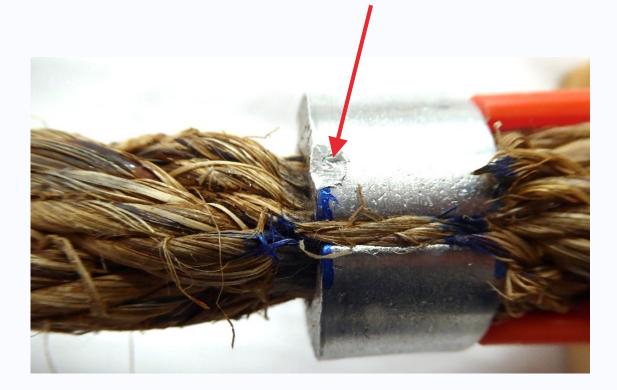
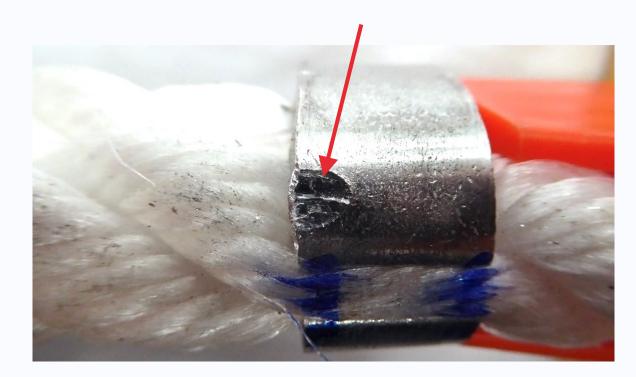
The hard shackles were able to damage the, relatively soft, metal fasteners – causing potential sharp edges

Hardness Testing	Large Shackle	Metal Fastener
Average (HV)	92	47

Method		Force achieved without slippage	Damage	Ease of use	Special considerations	Recommendations
D- shackle	27mm 36mm	2.8kN (maximum applied force)	Yes: to critical components of the pilot ladder	Very easy and quick	D-shackles may be considered an attractive securing option for personnel charged with rigging pilot ladders due to their ease of use. However, D-shackle use was demonstrated to transfer loading to the components of the step assembly resulting in damage to the structure and critical components of the pilot ladder.	Not recommended for use due to impact on ladder structure
Cow Hitch	Manilla, Polypropylene securing rope Lifting strap	<0.5kN (average)	No damage to the structure and critical components of the pilot ladder	Simple knot, low skill level	The cow hitch method did not damage the structure and critical components of the pilot ladder. However, the cow hitch method was demonstrated to deliver the worst holding performance of the three securing methods. The cow hitch always slipped, coming to rest on the step assembly – resulting in the undesirable situation where all the forces are concentrated on the step assembly.	Not recommended for use due to poor holding performance

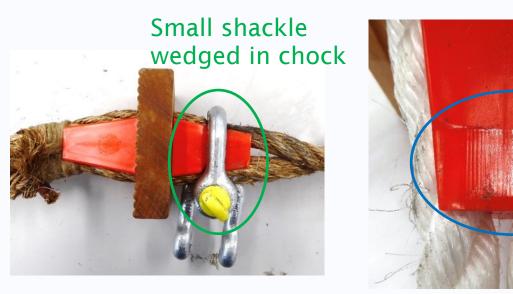
The small shackle travels past the <u>rope seizing</u> and gets wedged in the chock for both rope materials.

- The small shackle becomes wedged in the chock for both rope materials.
- This wedging means the chock becomes stuck and during unloading the chock can separate from the wooden step.
- The chock is damaged and permanent deformation of the plastic can be seen.

Damage to chock from shackle rubbing

Chock separates from wooden step

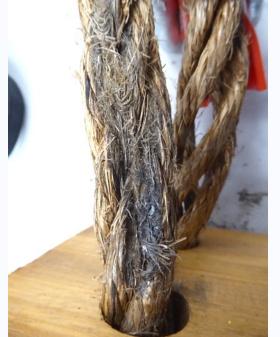
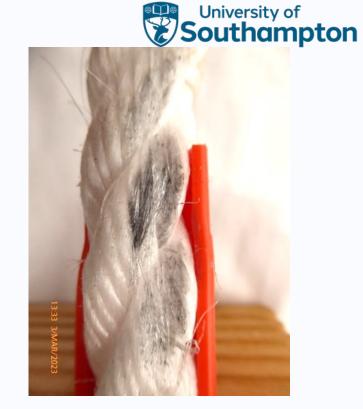
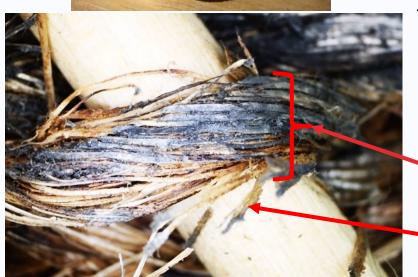
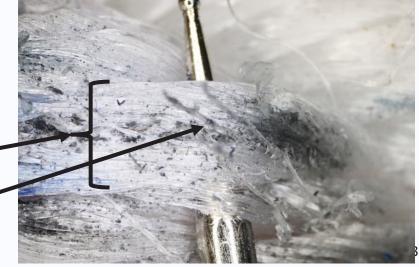
C² Results – Rope Wear / material transfer

- The small and large shackles rubbed against the ropes and caused some level of wear
- Greater wear on manila rope than polypropylene
- Grey colouring was coating
 transfer

Strand

Broken fibres
