# 1000 cruise ships around.....

## Are their pilot transfer arrangements safe?

Some words on cruise ships and their compliance with SOLAS ch.V reg 23, IMO A.1045(27)?

By: Arie Palmers, registered Pilot

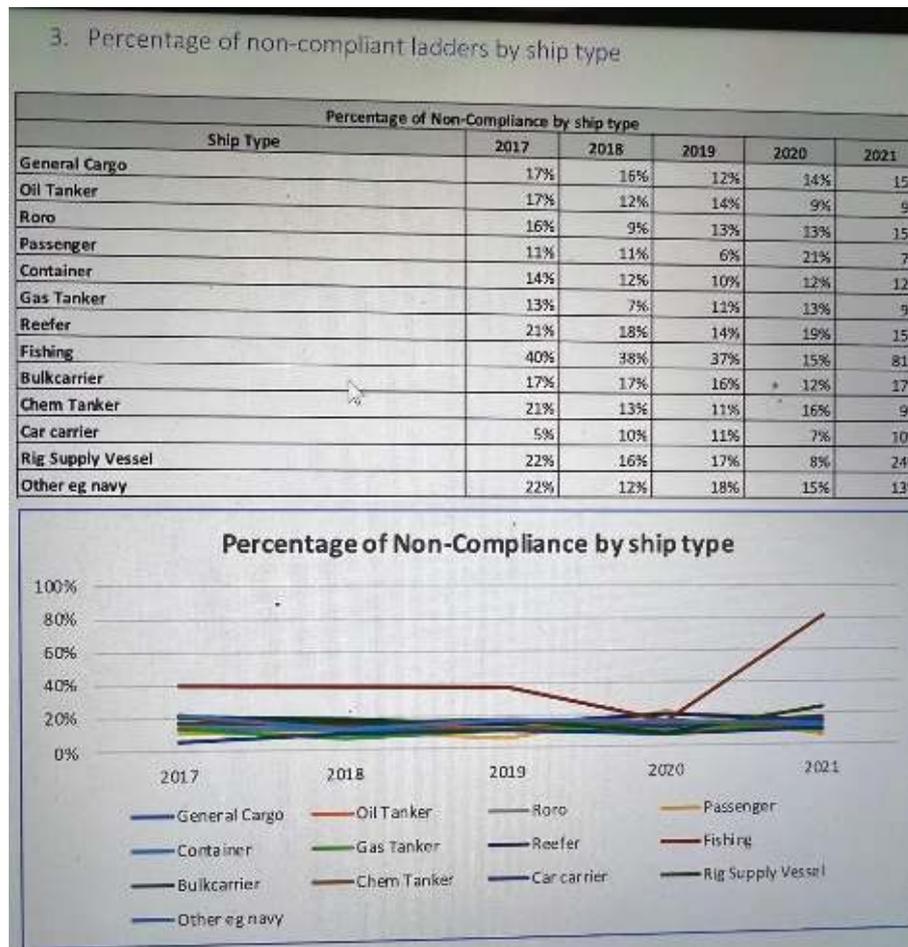
Year after year it seems that, despite the efforts of many, pilot transfer arrangements continue to be non-compliant. On passenger vessels we notice a variation between 7% and 21% non-compliance. It must be said that the last 2 years could be disturbing the overall results: cruise business was down due to Covid. In total the average in noncompliance according to IMPA is around 18%. In my own tally, published weekly on social media, there is a non-compliance of over 50%. This number is backup by the peer reviewed scientific paper “Snakes or Ladders” (E. Rattray et al).
